**Lady Berwick Pit**

Martletwy, Pembrokeshire

**Site Record**

**Landsker Explorer – Geospatial & Heritage**

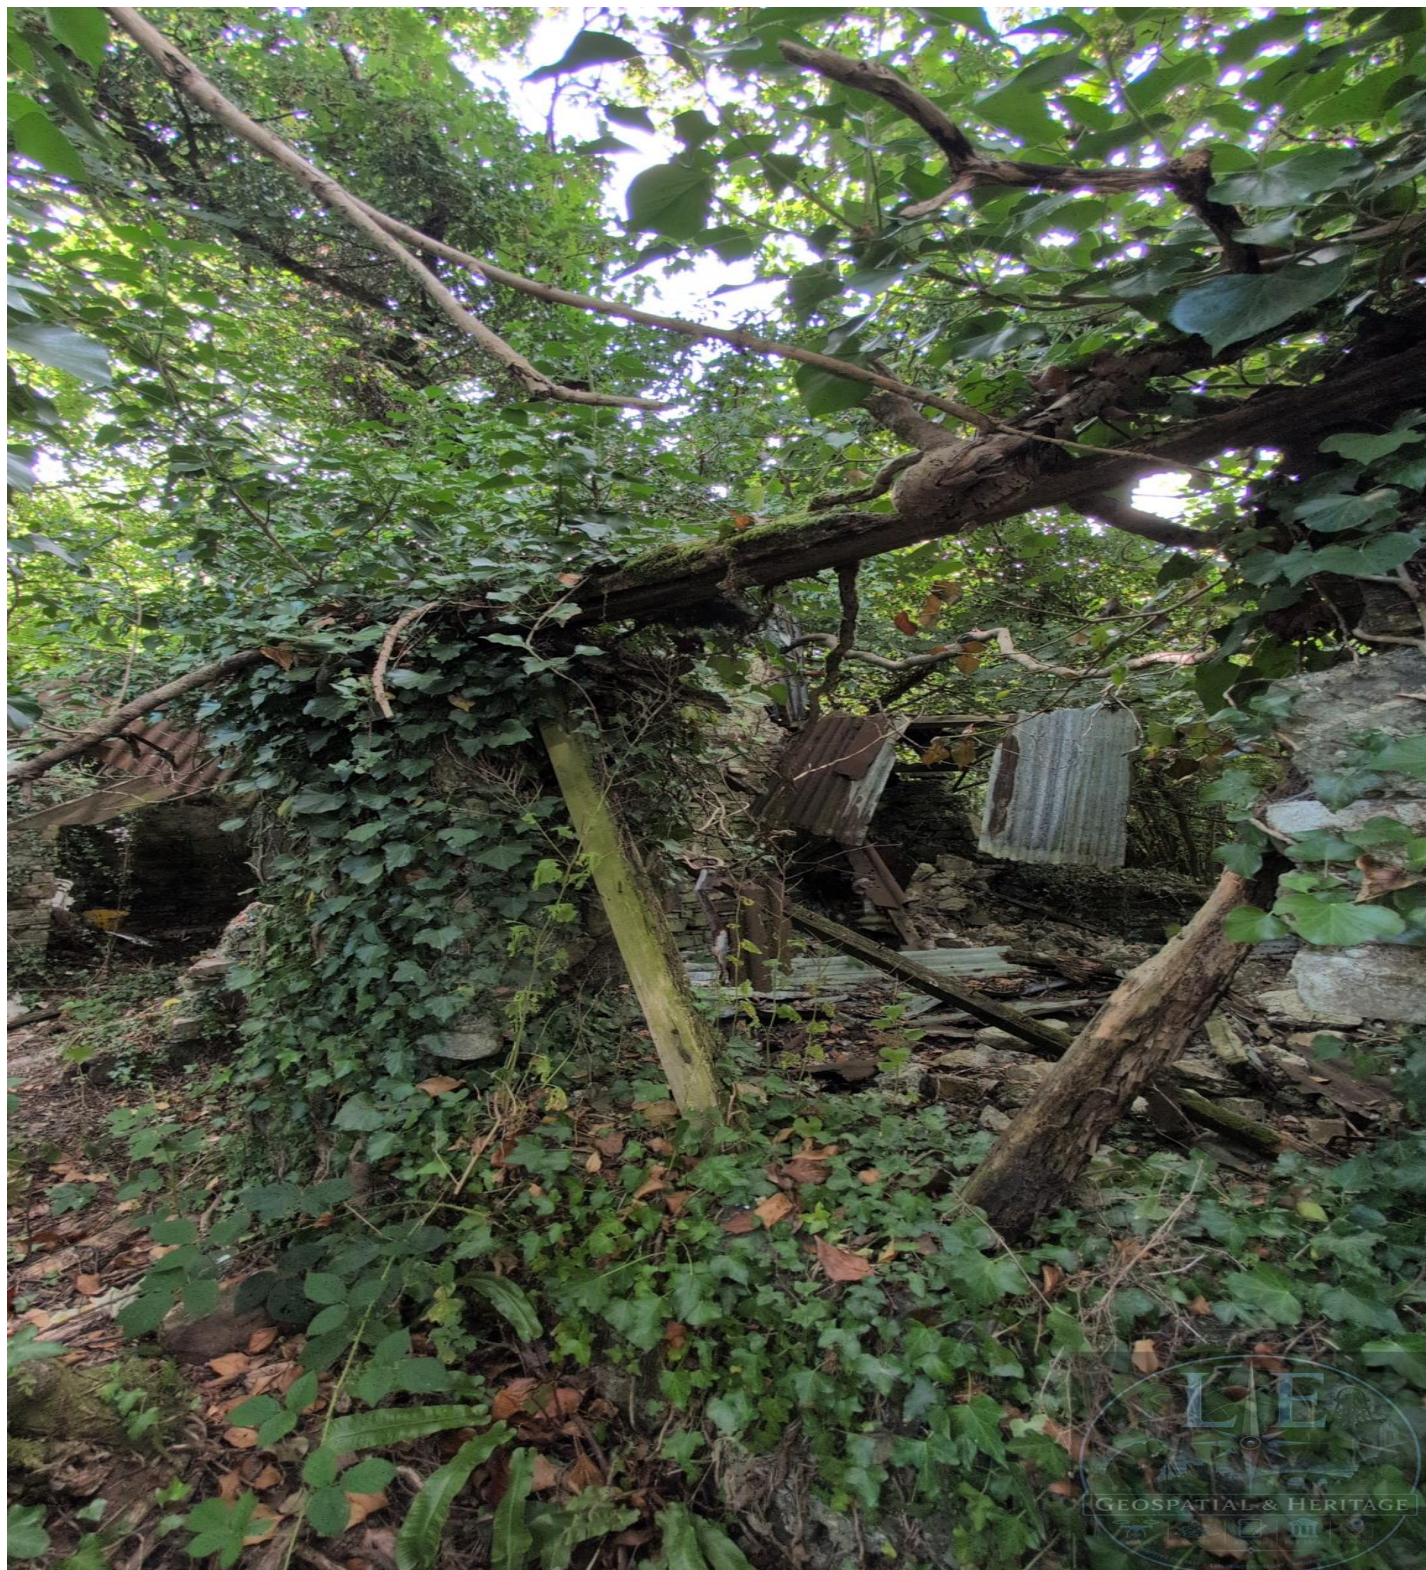
Figure 1

Immediately adjacent to the recorded position of the shaft stands a substantial masonry building constructed from locally quarried stone with extensive brick incorporated throughout its construction (Figure 1). Beside both the shaft and the building survive a substantial spoil tip composed predominantly of fractured slate and associated waste rock produced during underground excavation (Figure 2).

The spoil tip survives immediately adjacent to both the shaft and the building (Figures 1 and 2). This relationship is significant. Rather than occupying an isolated position elsewhere within the landscape, the spoil forms part of the same operational area as the surviving building.

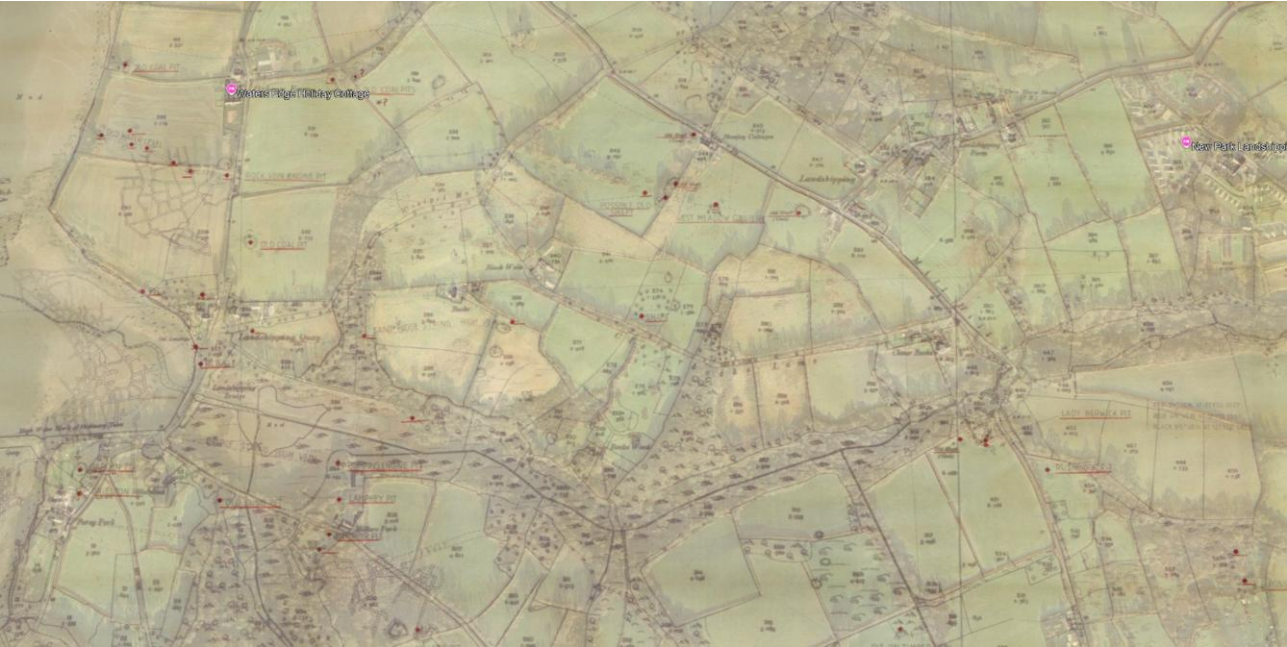
Figure 3

Historic mine plans record the position of the shaft together with associated workings forming part of the wider Landshipping mining complex (Figure 3). The Geological Survey records the shaft as an exploratory working undertaken to prove the coal measures south of the Old Mill Fault. During sinking, several coal seams were encountered before the shaft reached disturbed ground associated with the fault at a depth of approximately fifty-two yards.

Historic mapping clearly records the position of the shaft together with the adjacent building and associated spoil tip (Figure 3). Comparison with the modern landscape confirms that the principal archaeological features survive in broadly the same relationship today (Figure 2). Although the site has naturally deteriorated since mining ceased, the overall layout remains readily identifiable.

The mapping clearly identifies the corn mill as occupying a separate and substantially larger building situated across the road from Lady Berwick Pit (Figure 3).

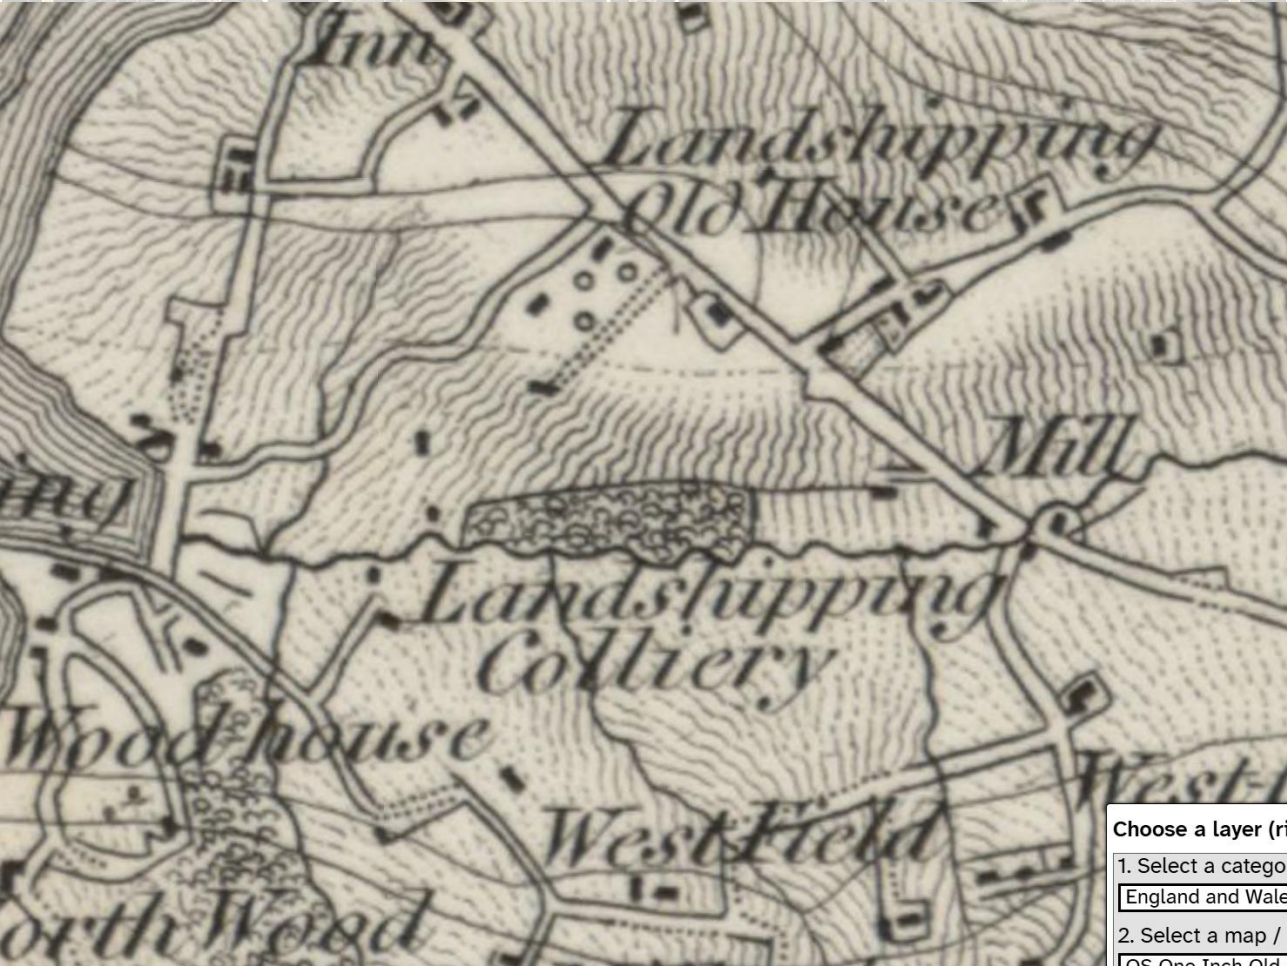
Figure 4

The building is constructed predominantly from locally quarried sedimentary stone bonded with lime mortar. Brick has been incorporated extensively throughout the structure, particularly around openings and in areas where greater structural accuracy or additional strength was required (Figures 4–6).

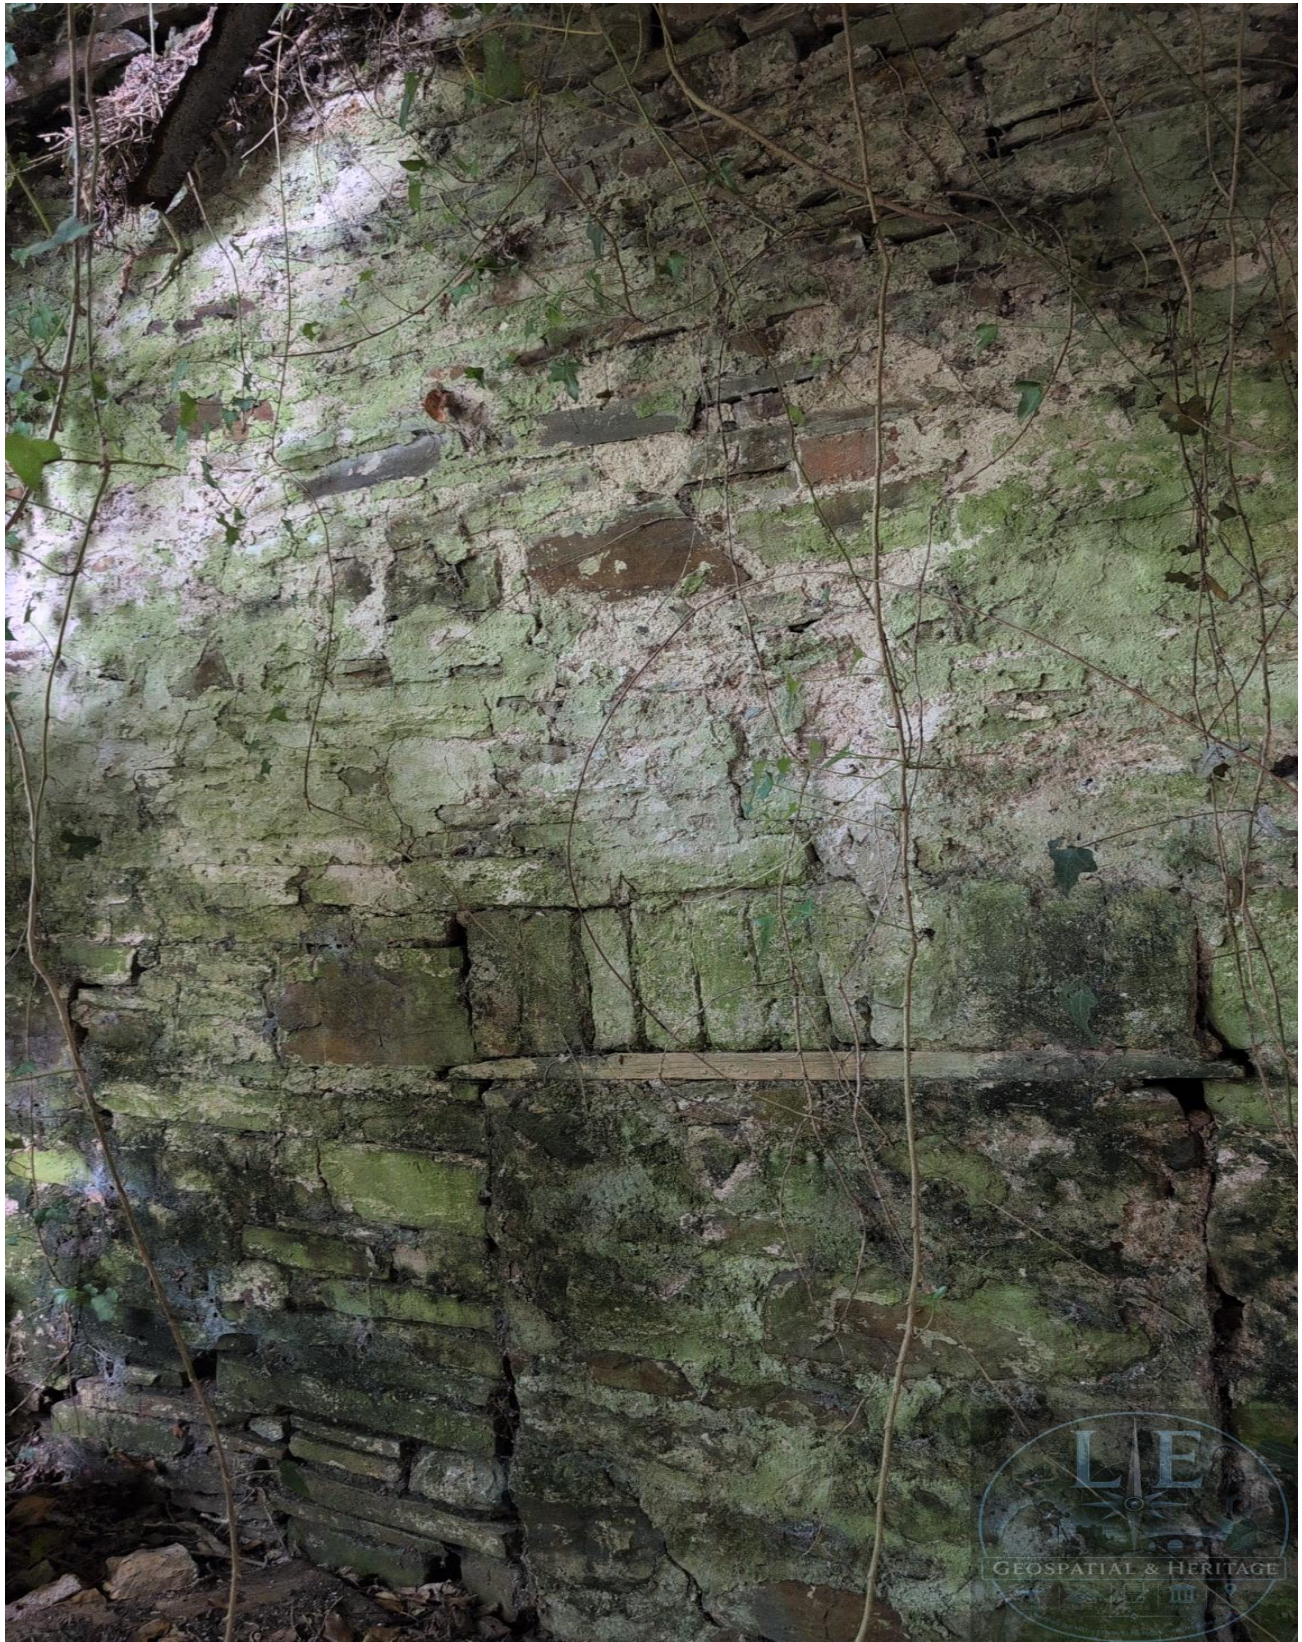
Figure 5

The surviving walls are exceptionally substantial (Figure 5). Their thickness immediately suggests that the building was intended to support significant loads rather than simply provide shelter.

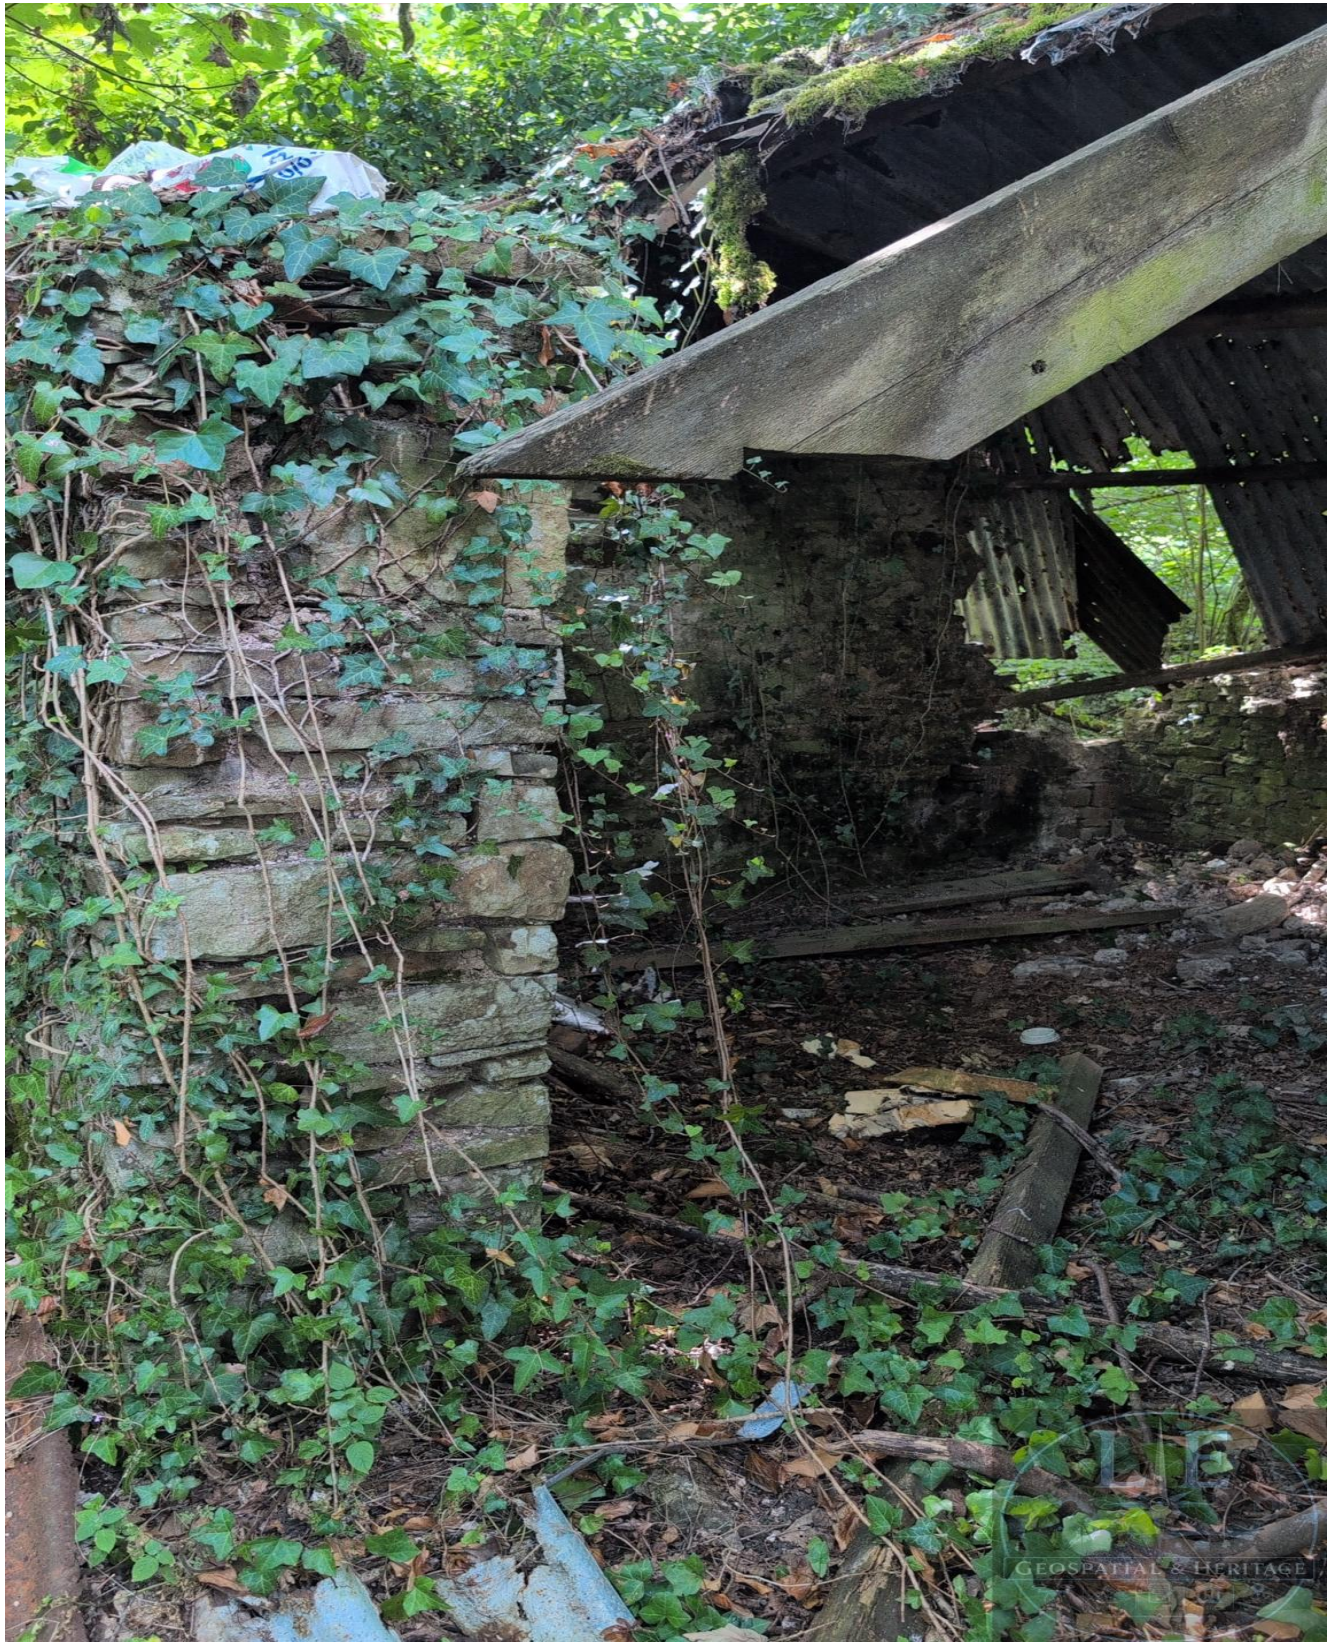
Figure 6

The principal dividing wall is comparable in thickness to the external walls and clearly forms part of the original design rather than representing a later subdivision (Figure 6).

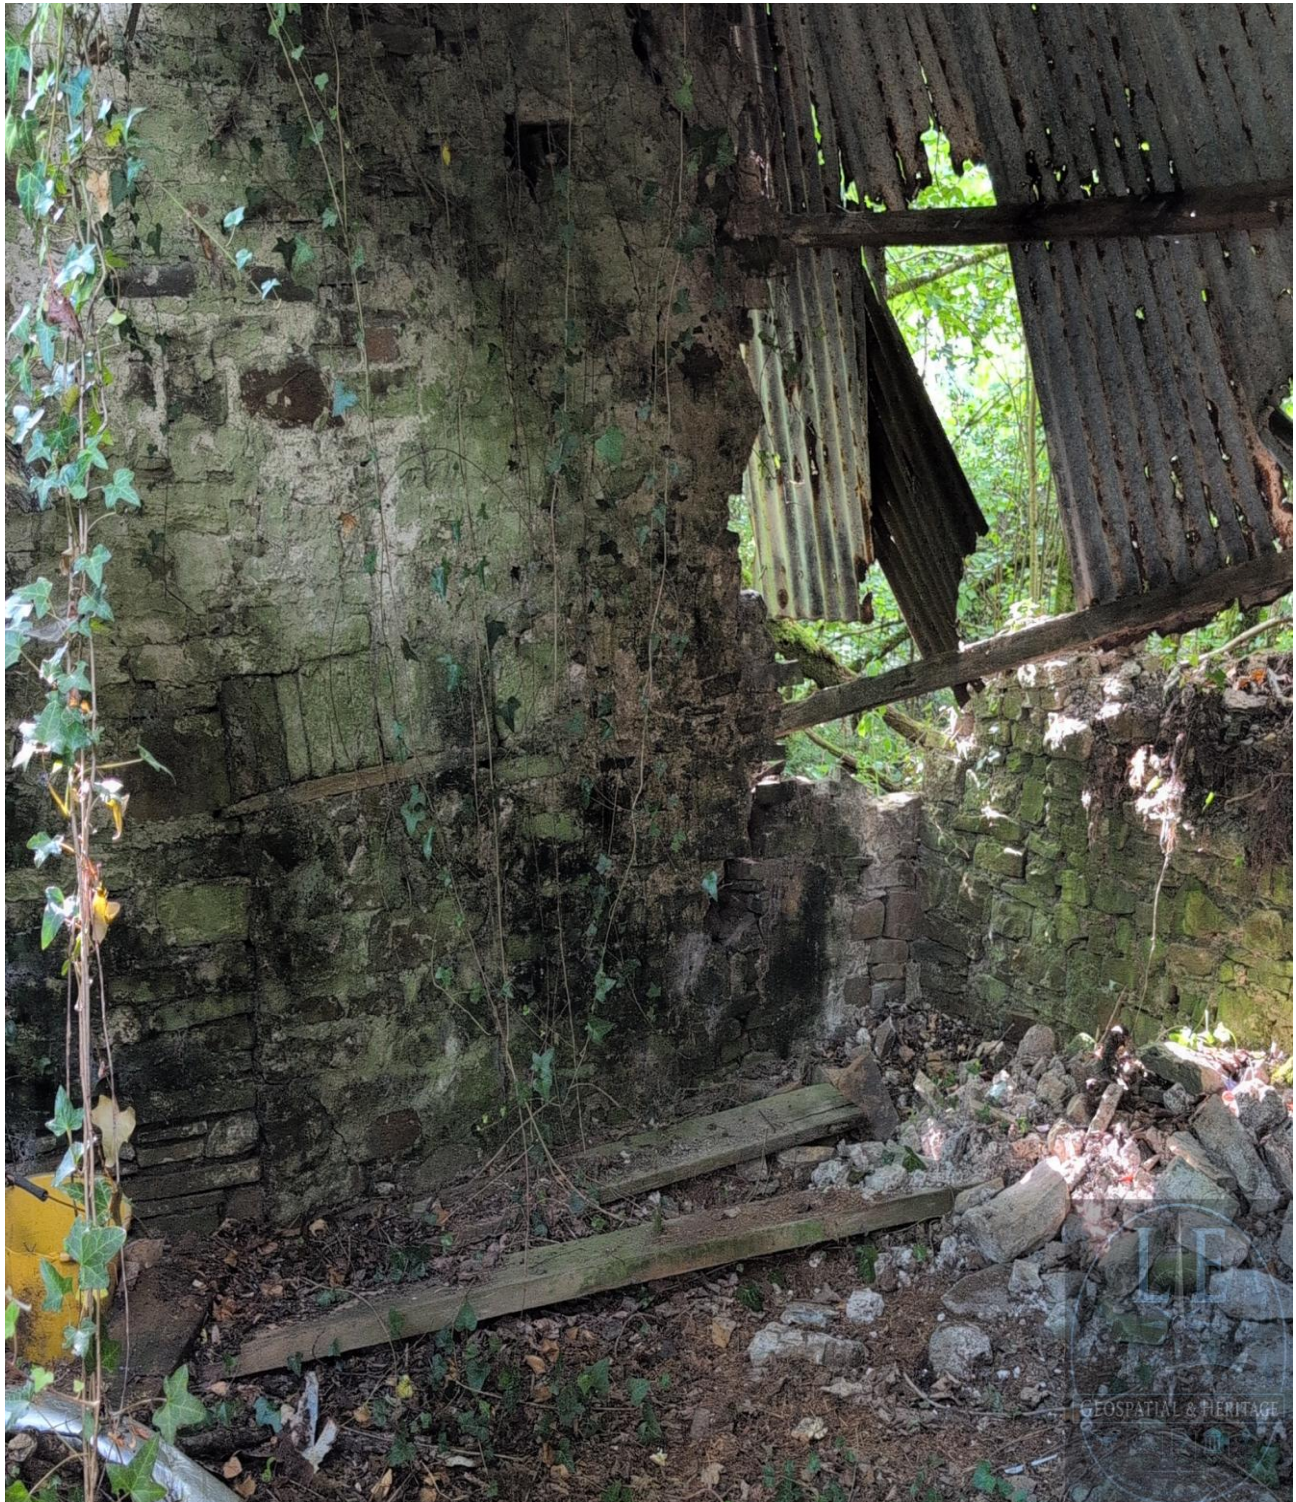
Figure 7

A substantial opening within the building has been deliberately blocked (Figure 7).

The blocking is clearly distinguishable from the surrounding masonry and demonstrates that the opening belongs to an earlier phase of the building before being intentionally infilled.

This alteration appears deliberate rather than the result of collapse.

More importantly, the blocked opening aligns directly with a linear feature surviving behind the building.

At present, the blocked opening and rear linear features are therefore considered more consistent with the discharge of pumped mine water than with the operation of a water-powered mill.

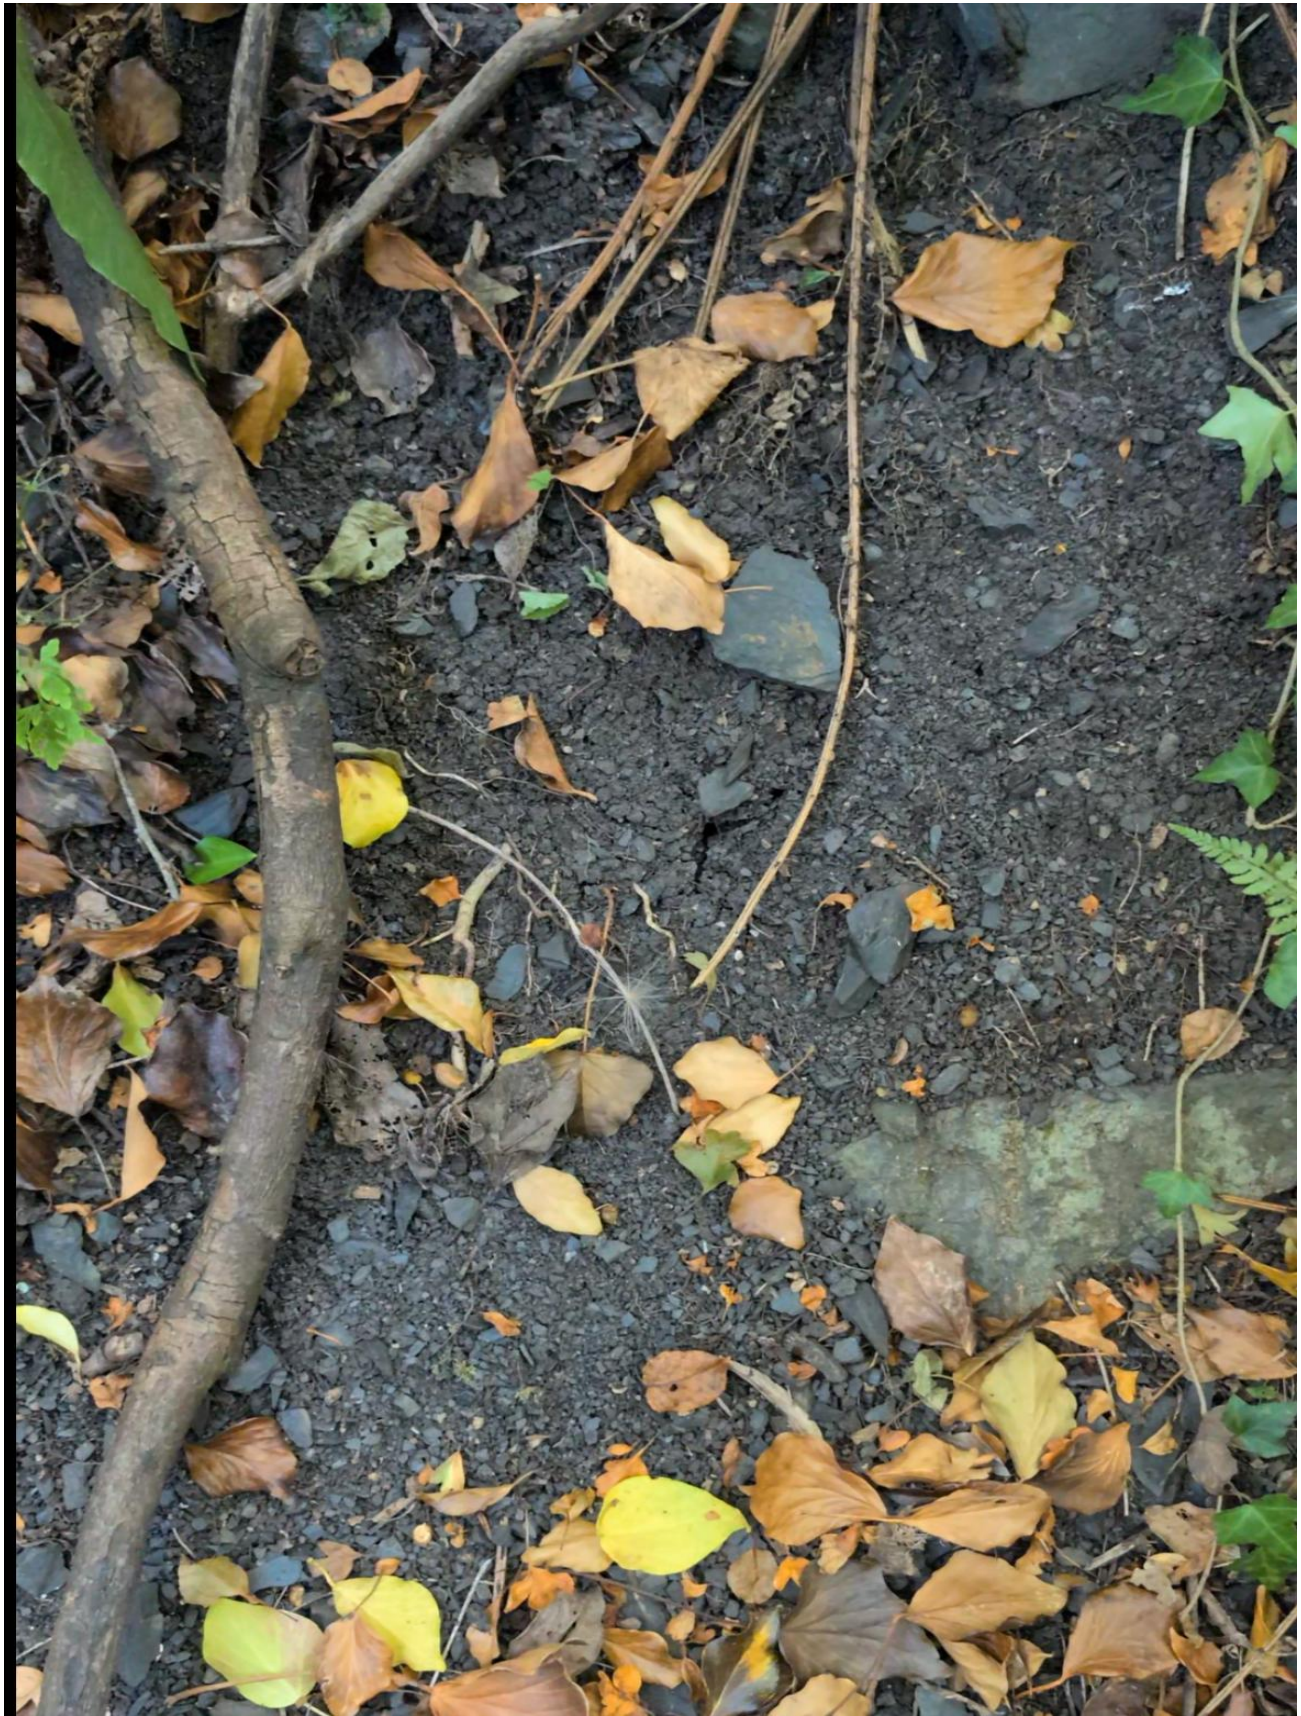
Figure 8

The material itself consists predominantly of fractured slate together with associated waste rock removed during excavation (Figure 8).

This is not naturally accumulated material; it is the direct product of mining activity.

Its composition appears entirely consistent with waste produced during excavation at Lady Berwick itself.

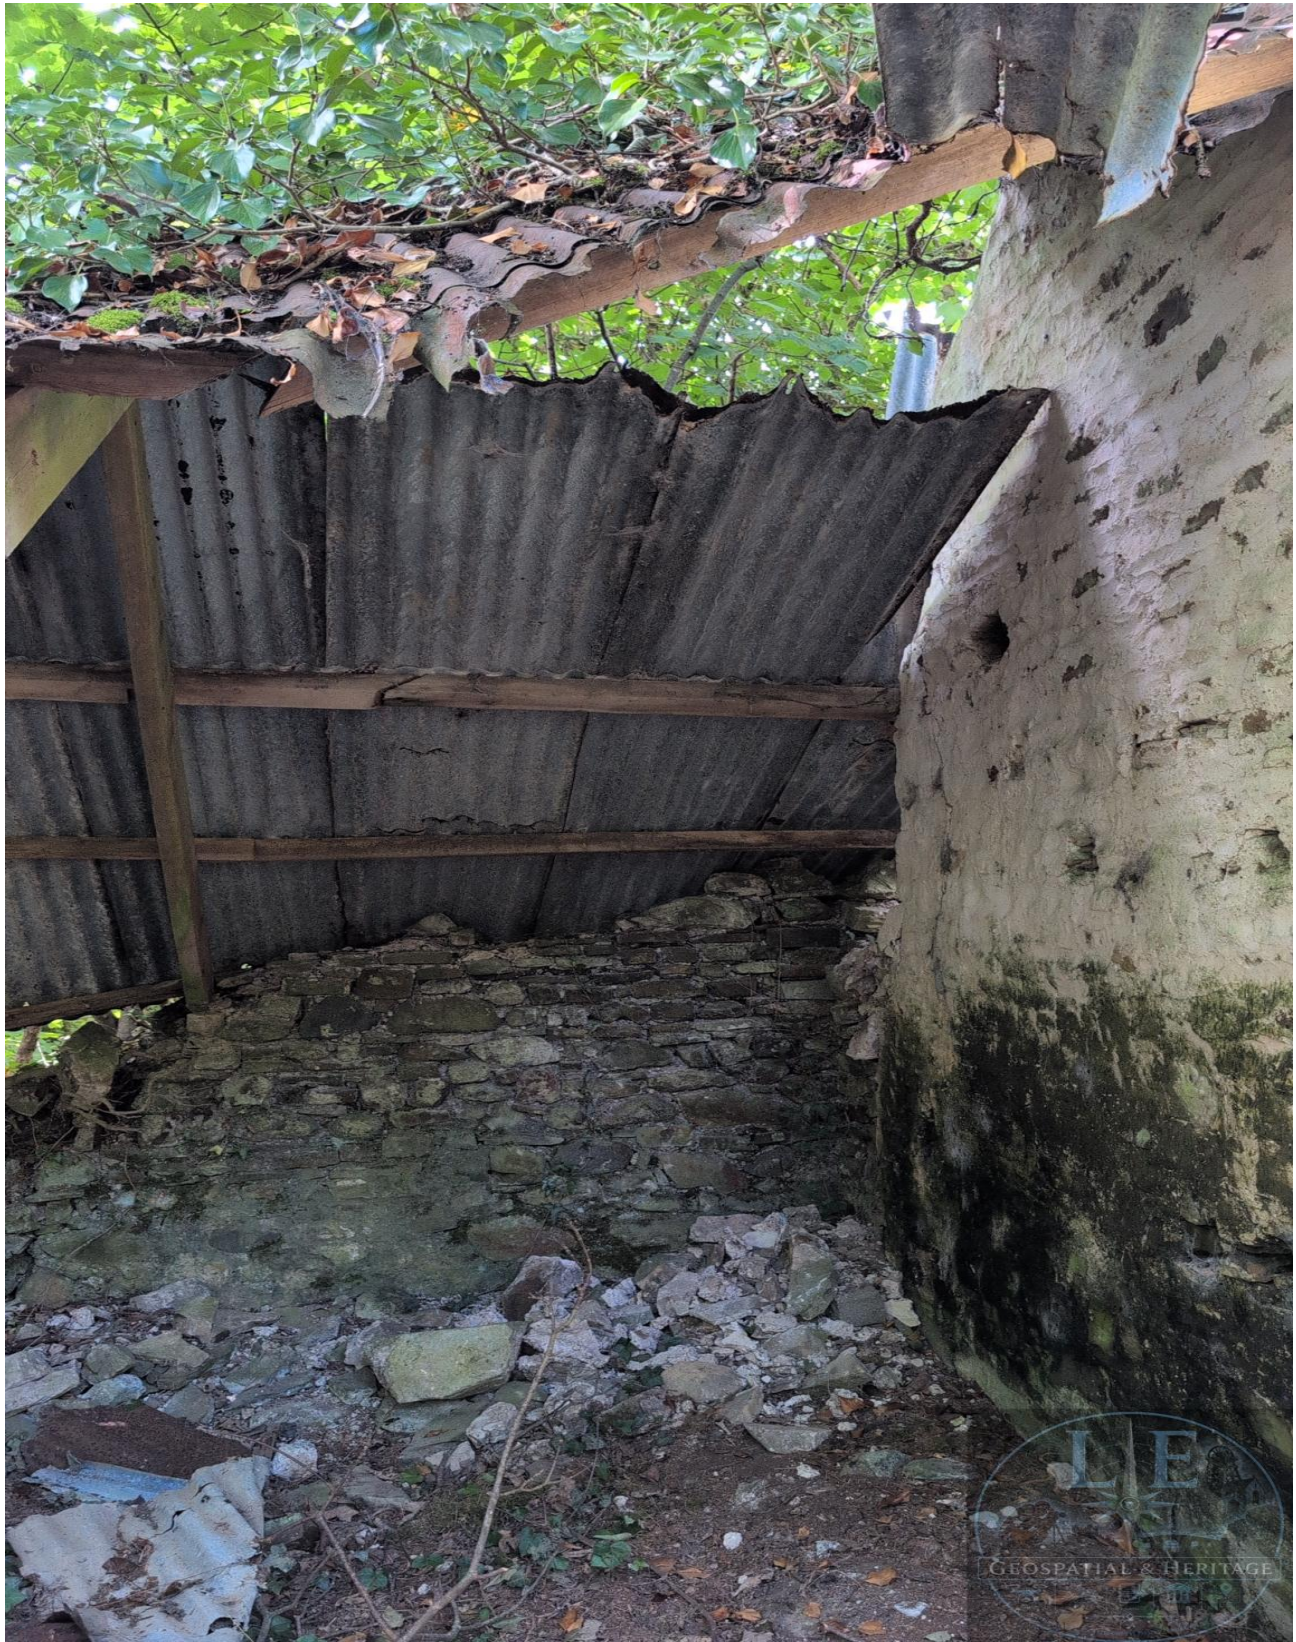
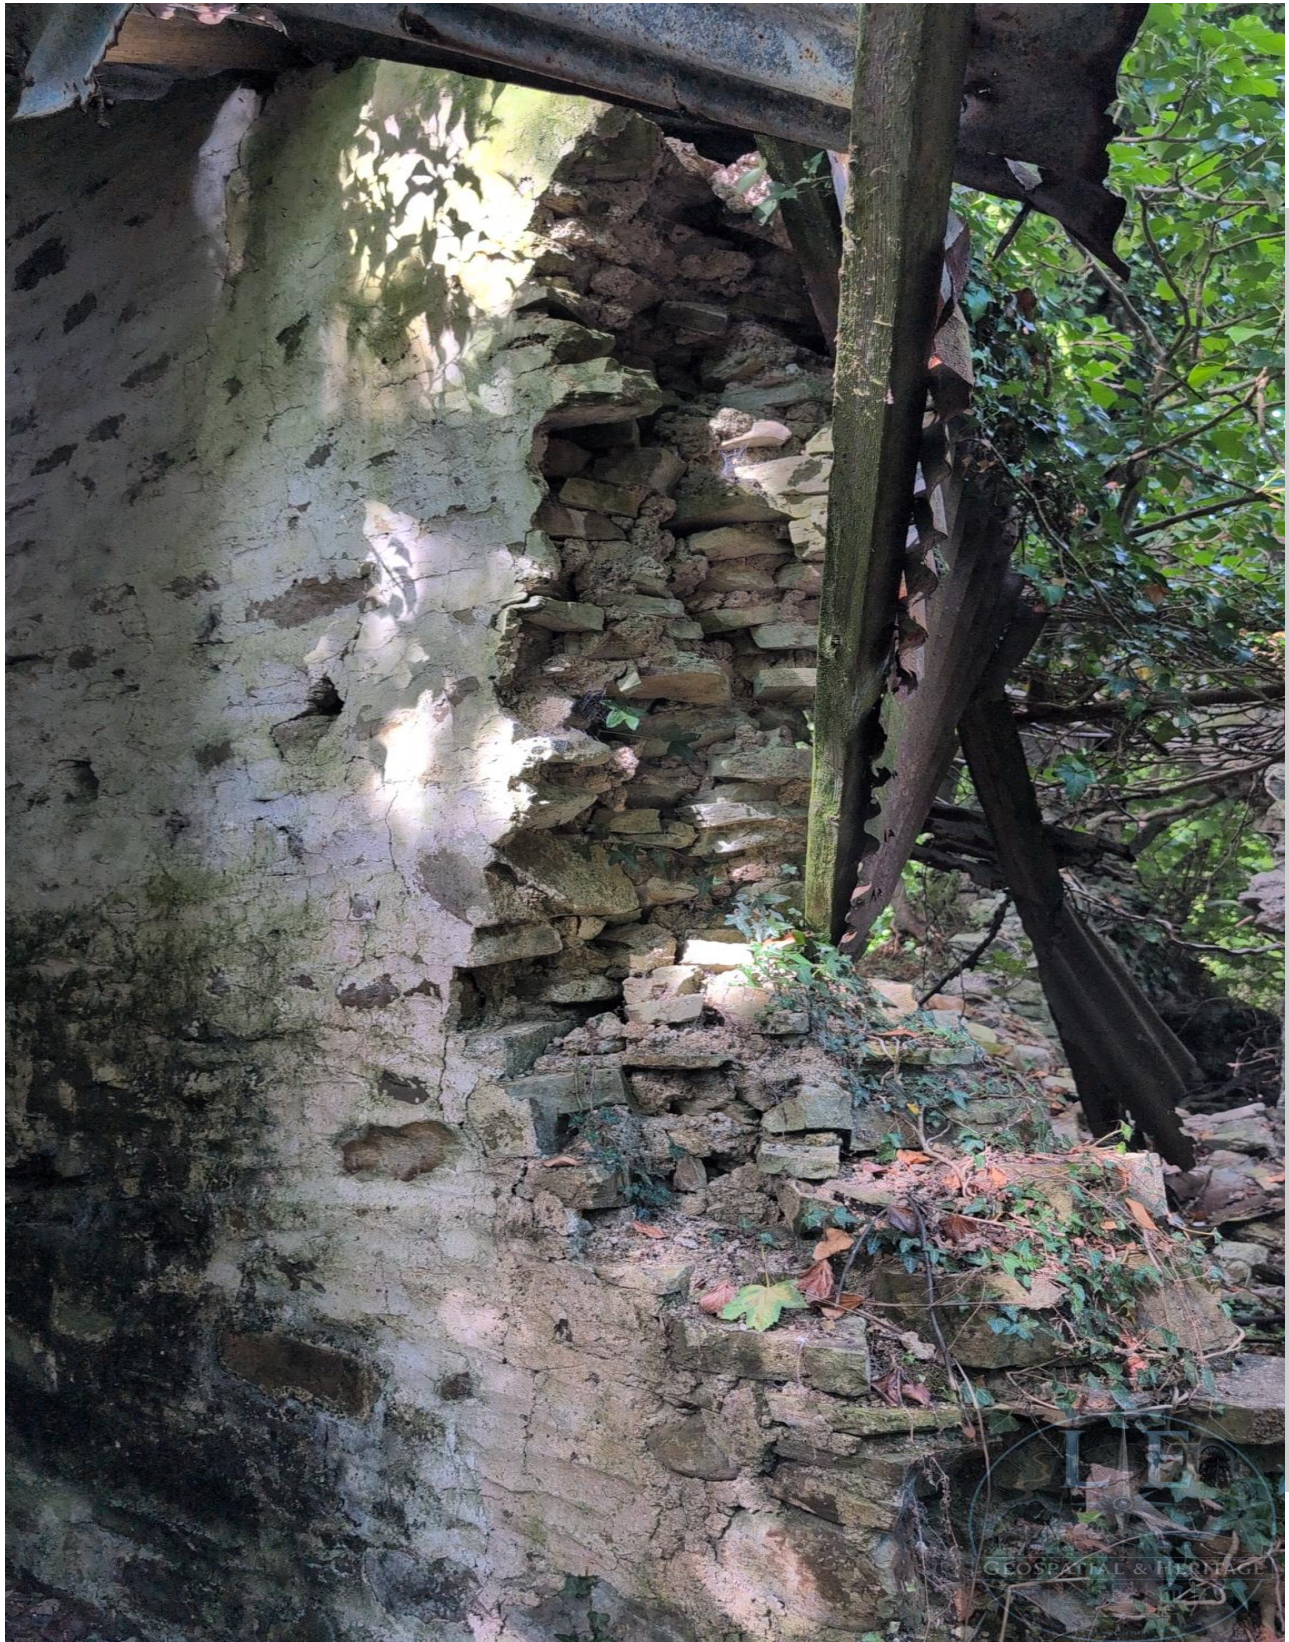
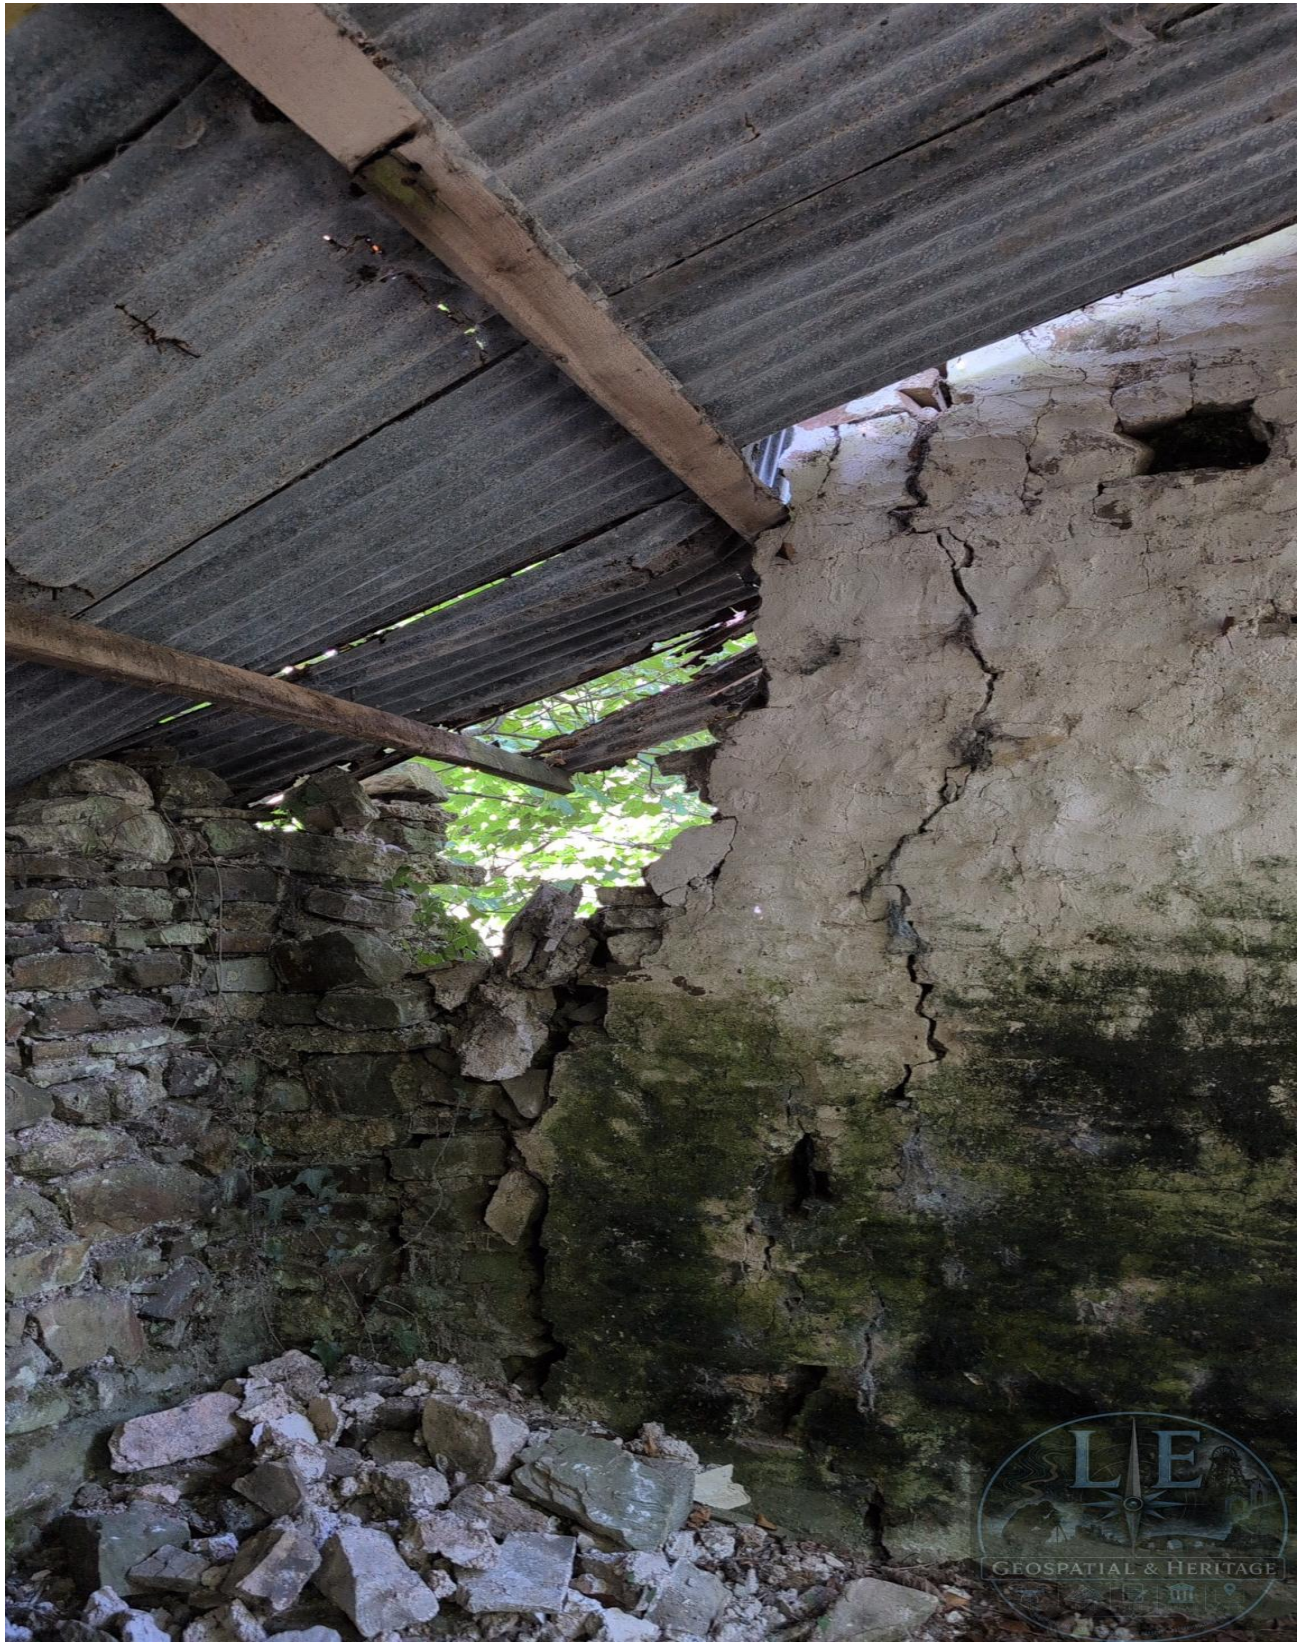
The most significant surviving feature is the substantial internal dividing wall (Figure 9-9.2).

This is not a lightweight partition inserted during a later phase of the building's life. It is built to the same standard as the principal external walls and forms part of the original structural arrangement. Its construction alone demonstrates that the internal layout was planned from the outset rather than adapted from a single open space.
